PROPERTY CONDITION ASSESSMENT
OF
WORLD TRADE CENTER PORTFOLIO

RETAIL MALL AND PLAZA

Property #3
Merritt & Harris, Inc. Project Number 20-251E

Re: Due Diligence Physical Condition Survey
World Trade Center
New York, New York

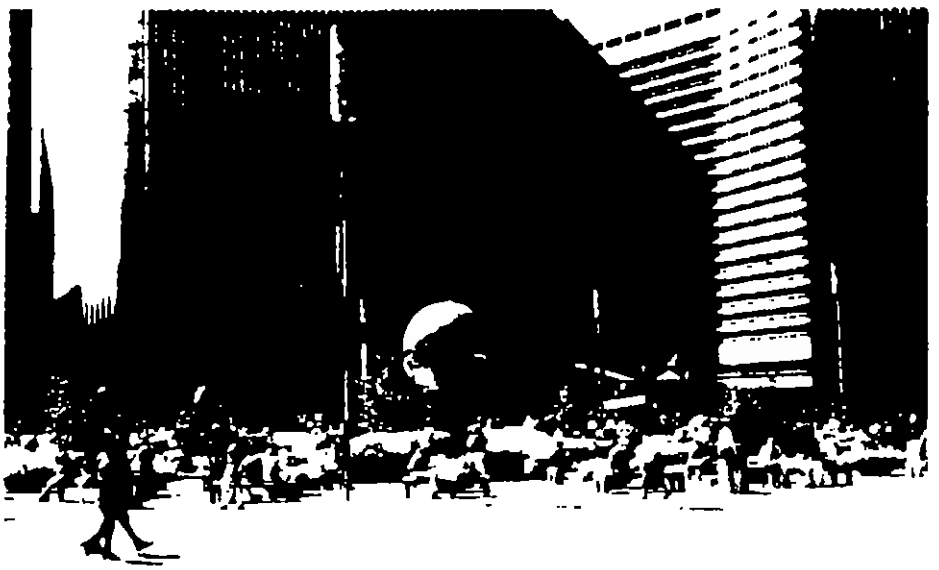
Photograph 3

Sidewalk conditions along Vesey Street near West Broadway

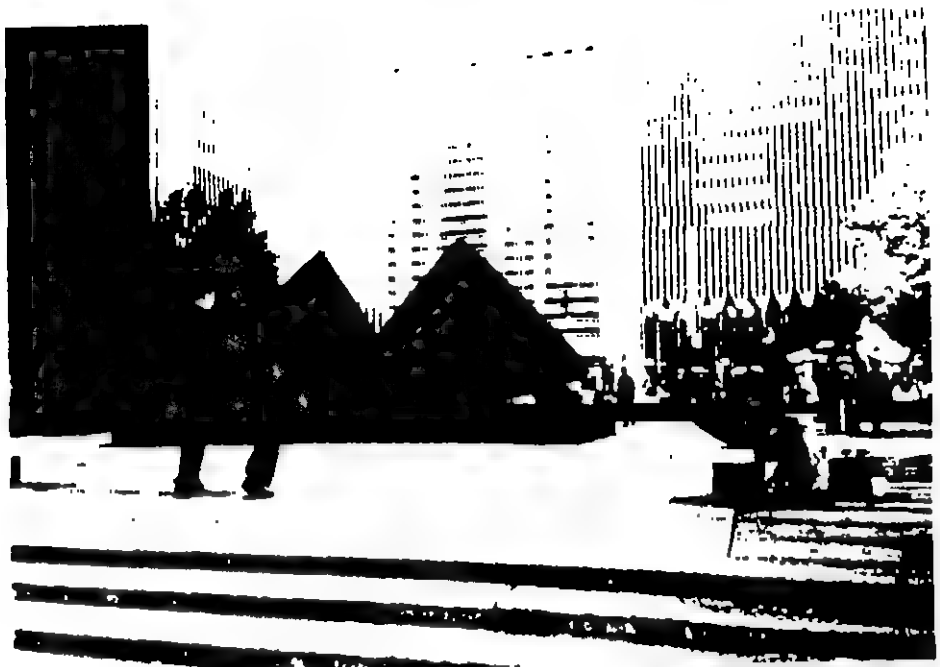
Photograph 12

Church Street steps entering Plaza

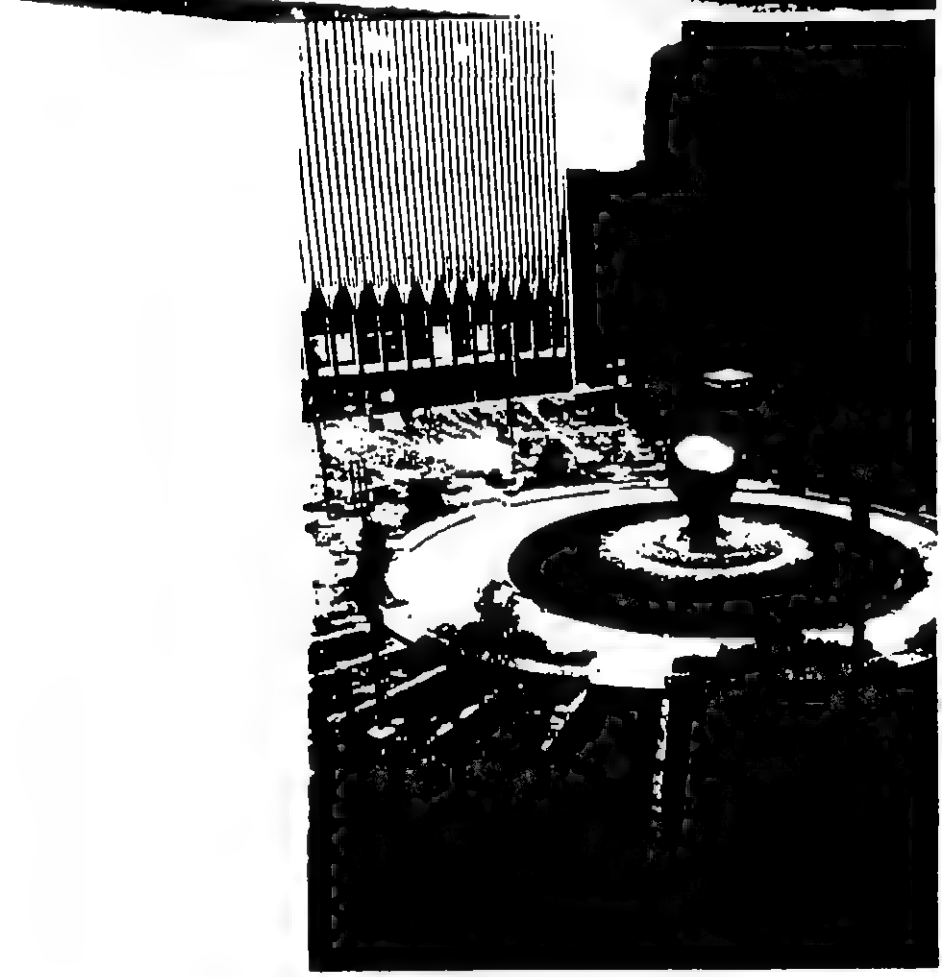
Photograph 16

Planter damage at Plaza level near 4 WTC

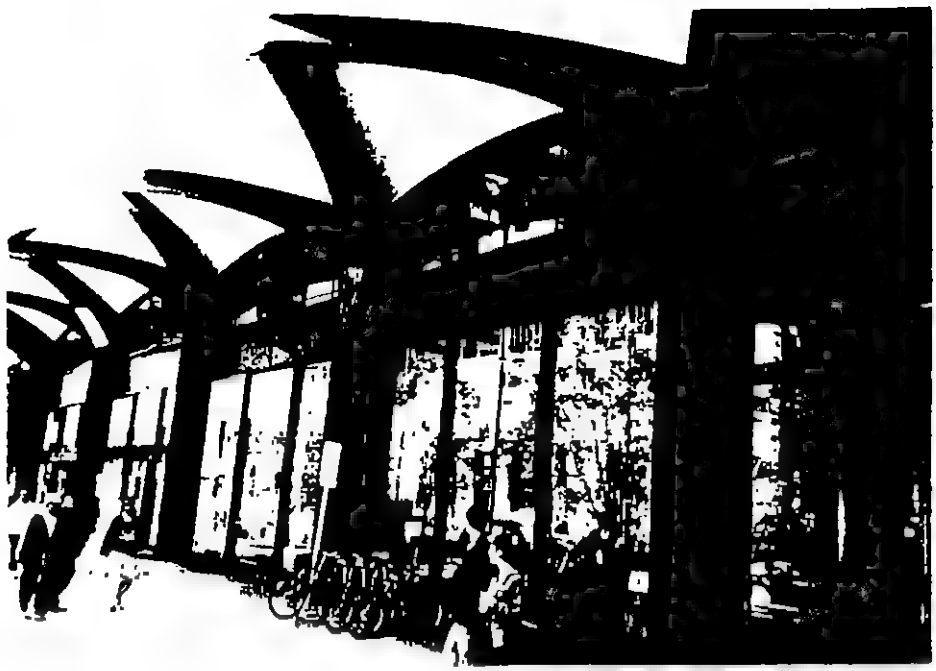
Photograph 22

Exterior finishes and space under overhang being used for restaurant seating

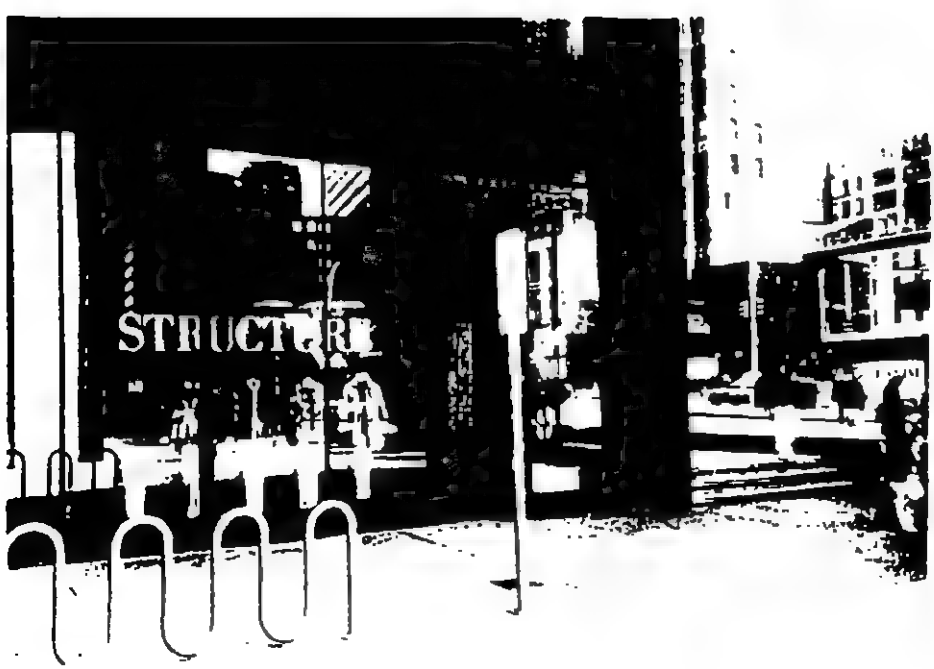
Photograph 25

Mall entrance detail along Vesey Street – Note exterior escalators to Plaza level on the right
